G.James Glass manufactures tinted, laminated, double glazed and other specialized glasses for the building industry.

Overcoming contamination and production delays.

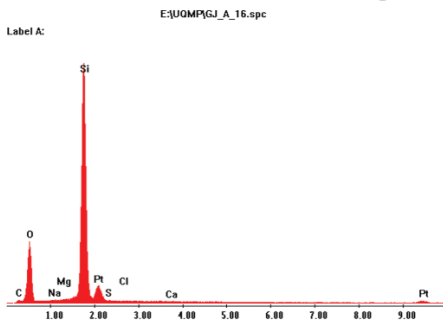
Initially, Future Materials’ University of Queensland Facility used a scanning electron microscope, which was able to demonstrate that there was contaminant on a roller. This indicated that something was there, however it could not confirm the source of the contamination as being the rollers themselves.

Then, using an even more sophisticated analysis with Electron Dispersion Spectroscopy (EDS), it was identified that the contaminant on the rollers was not refractory or metal based. Further investigation indicated that the contaminant was linked to the breakdown of feed stock into particulates within the furnace. Without such instrumentation, identifying the cause of the contamination would have been difficult and time consuming due to the physical similarities and appearances of the potential contaminant sources.

The identification of degraded glass as the contaminant, lead G.James to establish an improved maintenance protocol for the routine cleaning of fracture glass from its furnaces. Upon implanting this protocol there have been NO incidences of contaminated related product quality issues.
